## Case Study: Jacuzzi Tub Leak

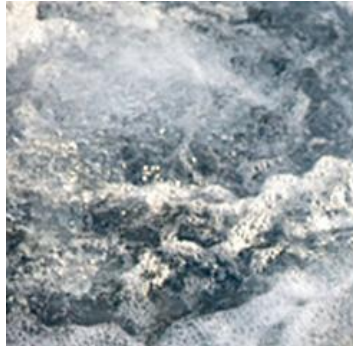
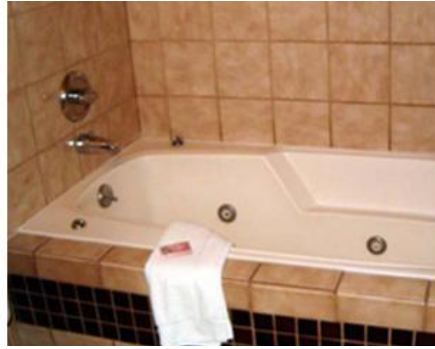
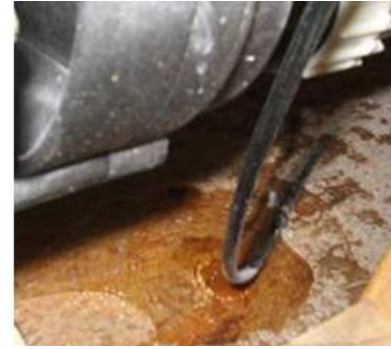
We checked out the jetted Jacuzzi tub upstairs in the ensuite Bathroom. Our testing process included filling the tub with water, running the circulating pump and motor, looking for any obvious leaks, observing the volume of the running noise and reviewing proper usage with our client.

Once finished, the drain stopper was pulled to allow the tub to drain. Shortly thereafter, a deluge of drain water poured from a separated drain pipe connection (unseen) and leaked onto the ceiling above the kitchen. To the clients' horror, water then began to flood uncontrolled through an electrical service box cover ("*the weakest point*") and onto the kitchen island countertop...

We documented this obvious flaw and the water-damage. It was evident this was an original deficiency – one which should not have been there and was an ‘accident waiting-to-happen’. GOTCHA! However, the situation was fixable (*if one cut-open the damaged ceiling, accessed and repaired the drain pipe leak, and then restored the ceiling and re-textured to match*)
