## INTRODUCTION TO ENHANCED AEROBIC BIOREMEDIATION

## ENHANCED AEROBIC BIOREMEDIATION CASE STUDY USING IXP<sup>®</sup> 70C CALCIUM PEROXIDE

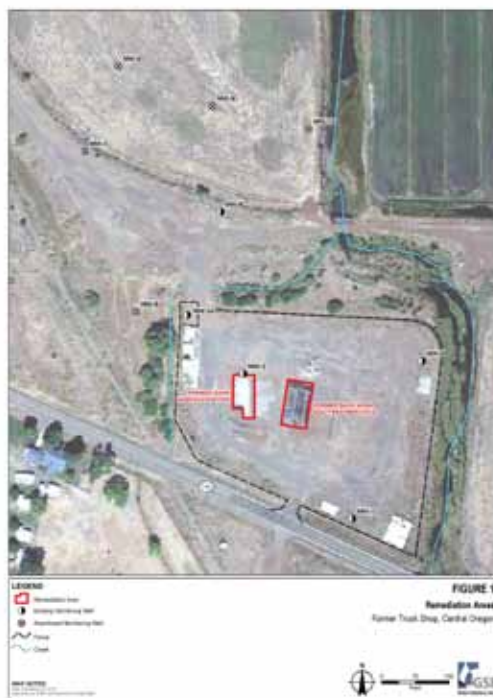
Figure 1. Remediation areas: former truck shop site, Central Oregon

Environmental investigations were conducted by GSI Water Solutions, Inc. at a former truck shop in central Oregon to characterize contaminated soil and groundwater. Findings from the investigations indicate that elevated concentrations of petroleum-contaminated soil were located beneath the former shop area (shop area). A work plan for site work at the former truck shop was submitted and approved by the Oregon Department of Environmental Quality (DEQ) in August 2011 summarizing the site conditions and site conceptual model as well as the cleanup goals. The proposed remediation work included, excavating fuel impacted soils, and constructing a soil treatment pile (STP). The location of the impacted area at the truck shop site is shown in Figure 1.

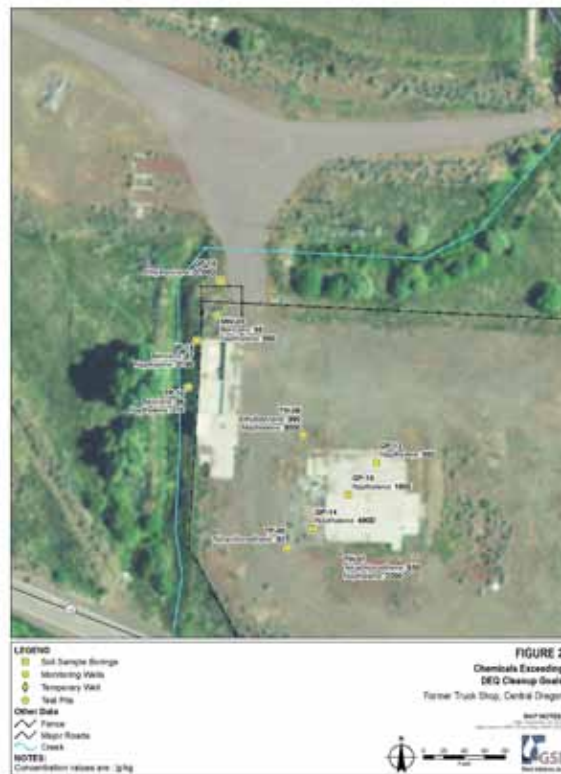
Figure 2. Soil boring locations of compounds found in exceedance of Oregon DEQ cleanup criteria

Numerous subsurface soil borings were obtained during several site characterization investigations between 2002 and 2005. Concentrations of the following compounds were found on-site in the fueling and shop areas that exceeded Oregon DEQ risk-based concentrations (RBCs): gasoline-range total petroleum hydrocarbons (TPH-G), benzene, and ethylbenzene (Figure 2).

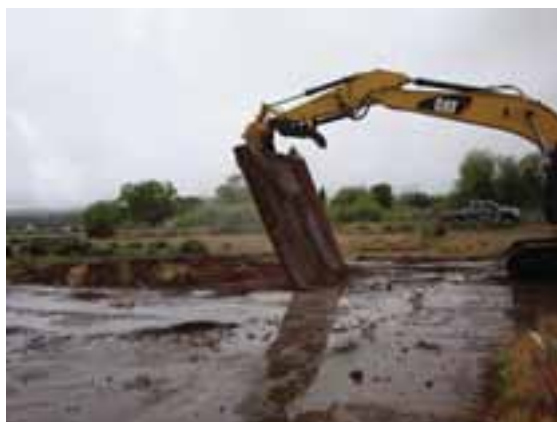
Figure 3. Breaking up concrete floor slab in former shop area to prepare for soil excavation (June 2012)

- **Concrete Slab.** The concrete slab in the shop area was removed and stockpiled onsite before beginning the excavation.

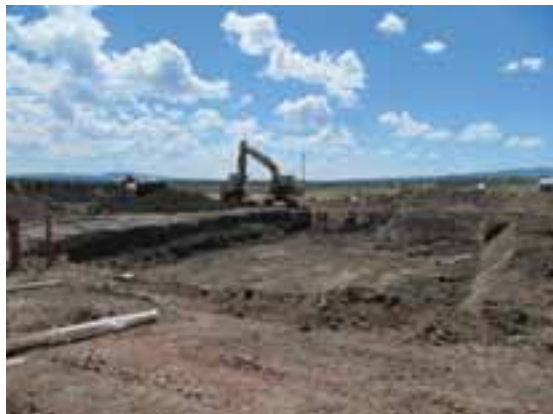
Figure 4. Completed excavation in former shop area (July 2012)

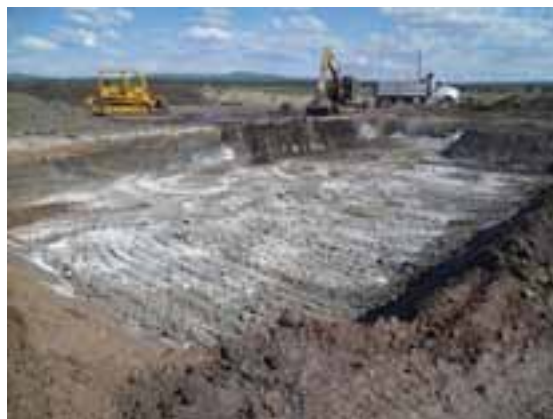
Figure 5. IXP<sup>ER</sup>® 70C Calcium Peroxide placed in the bottom of the completed former shop area excavation (July 2012)

To accelerate aerobic biodegradation, 3,300 pounds of IXP<sup>ER</sup> 70C was mixed to a depth of 6-inches with soils in the floor of the excavation. The soil treatment pile (STP) was constructed in a single cell with a height of about 5 feet. The STP was located to the east of the former shop area and placed on a reinforced polyethylene liner to provide a relatively impervious bottom. The excavated soil was first placed on a concrete pad immediately east of the excavation area. IXP<sup>ER</sup> 70C and a small amount of water was mixed with the soil and then placed in the STP. A total of 8,700 pounds of IXP<sup>ER</sup> 70C was added to the STP resulting in an estimated 0.5 percent concentration by weight and applied at a rate of 1 pound per 5,000 pounds of soil. After completion of the STP, the area was lightly sprayed with water to provide moisture and covered with polyethylene sheeting. The cover was then anchored with clean soil. Figures 4 through 8 illustrate the process of excavation and treatment pile construction as well as IXP<sup>ER</sup> 70C emplacement and the well-blended IXP<sup>ER</sup>-amended soil in the STP.

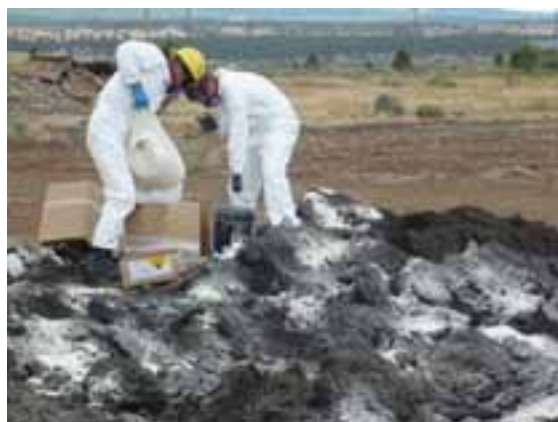
Figure 6. IXP<sup>ER</sup>® 70C Calcium Peroxide being added to the soil treatment pile (July 2012)

- **Treatment Pile.** IXP<sup>ER</sup> 70C and water were mixed with the soil as the treatment pile was being constructed. The water was added to the soil as needed so that it had adequate moisture for biological growth. The treatment pile was constructed adjacent to the shop area on an impervious liner over an area about 60 feet by 100 feet with slopes no greater than 2.5 to 1. After the treatment pile was constructed, the pile was covered with an impervious cover and anchored to prevent dislodging in the event of high winds.

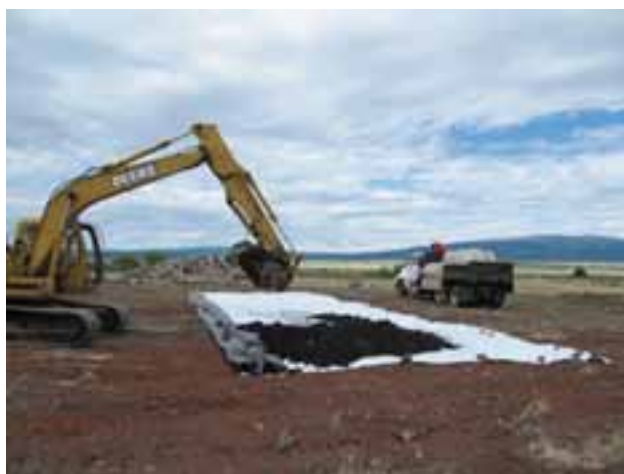
Figure 7. Construction of IXP<sup>ER</sup> 70C enhanced aerobic bioremediation soil treatment pile on liner (July 2012)

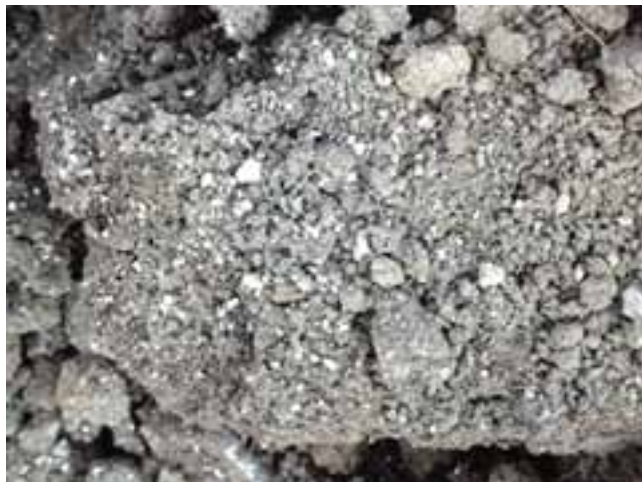
Figure 8. IXP<sup>ER</sup>® 70C Calcium Peroxide blended into treatment pile soil

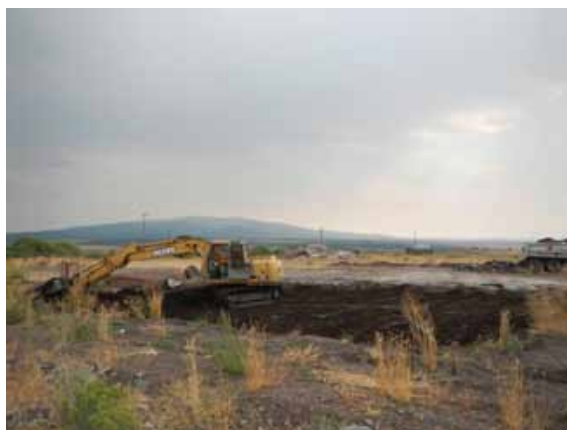
Figure 10. Backfilling nearly completed in the excavation area (August 2013)

The selected remedy of utilizing IXP<sup>ER</sup>® 70C Calcium Peroxide for enhanced bioremediation of soil treatment piles at the former shop area has been successful. The final remaining task, to backfill the treated soil pile into the excavated area and cover with fresh soil and vegetation, was completed in August 2013. An additional 1,000 pounds of IXP<sup>ER</sup> 70C was added to the bottom of the excavation prior to backfilling to ensure continued treatment of these areas following backfill operations. Stockpiled clean overburden gravel was placed over the filled excavation to provide a clean cap over the treated soils. The excavation area was graded to drain (Figure 10).
