Willamette River Foam Investigation – December 11, 2012

Overview

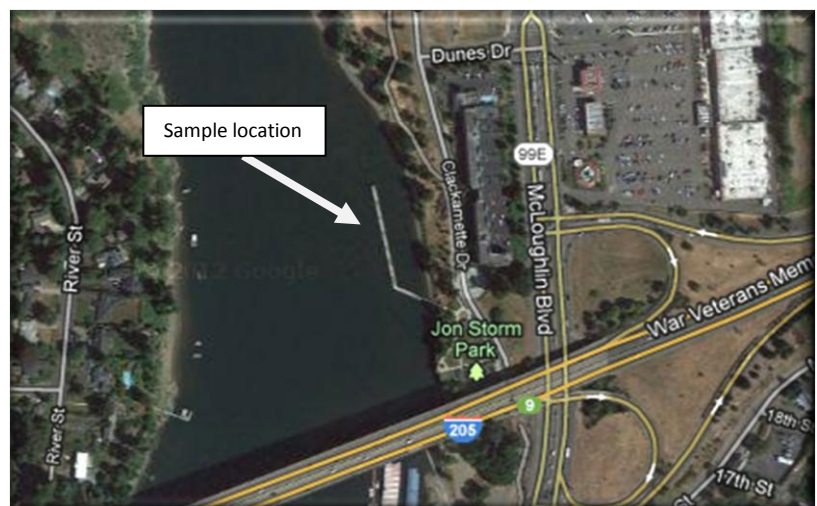
Figure 1 Water quality sampling location at Jon Storm boat ramp.

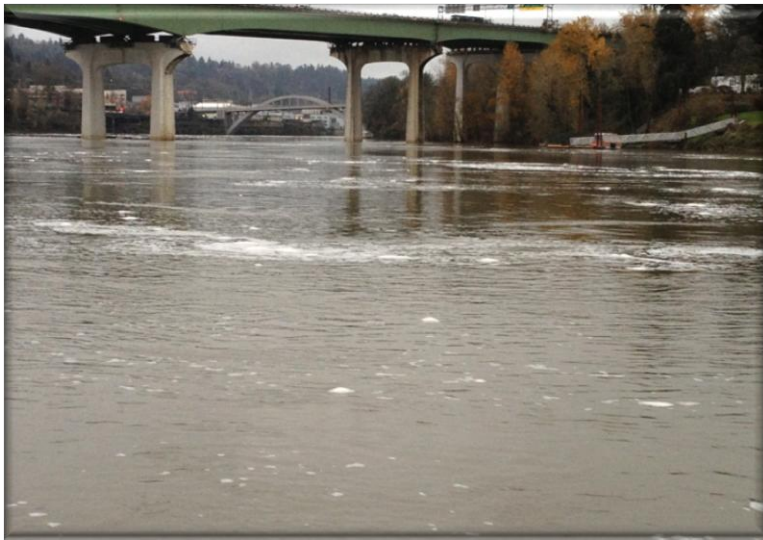
Figure 2 Foam accumulations on the surface of the Willamette River downstream of Willamette Falls. The highway 205 overpass is visible in the background.

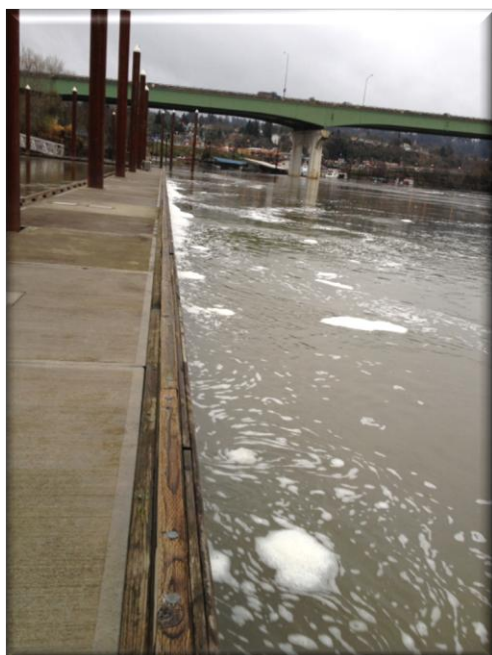
Figure 4 Foam piling up on boat ramp.

The location and conditions at the time of sampling were optimal. Foam accumulating on the boat ramp provided easy access for sampling to characterize the water quality (Figure 4 & 5). The foam collected in mats along current eddies as it drifted downstream (Figure 6). The foam on the side of the ramp appeared cream colored with brownish streaks running through it (Figure 7). Water quality results did not suggest anything unusual about the water quality. The dissolved oxygen levels were high, which is normal, below

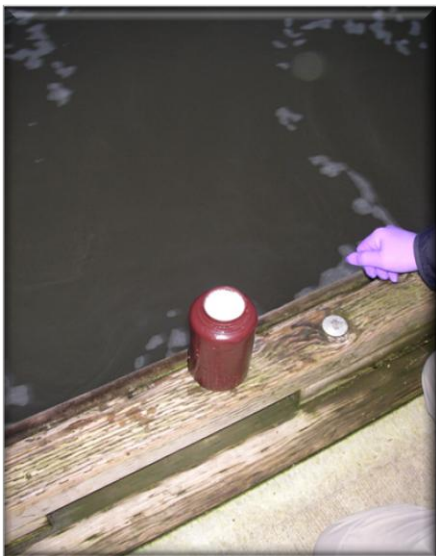
Figure 5 Foam collected in a sample jar for phytoplankton analysis.

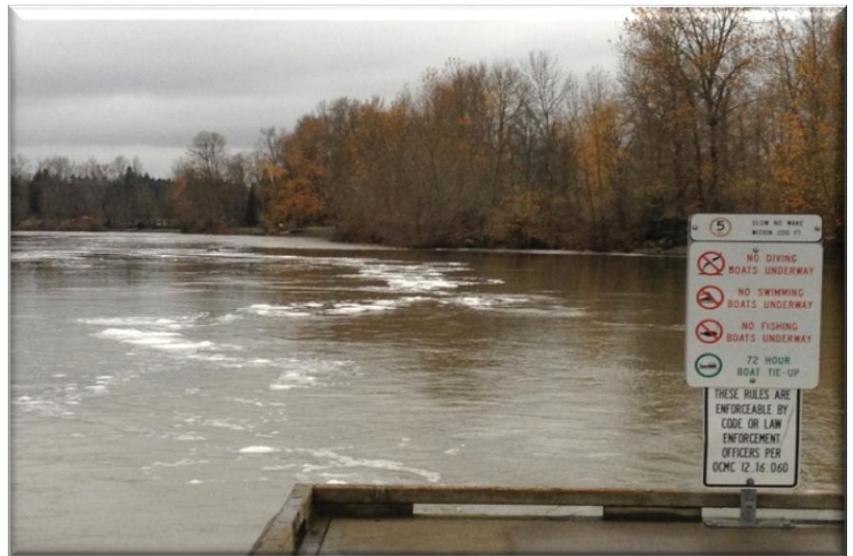
Figure 6 Foam mats collecting in eddies looking downstream.

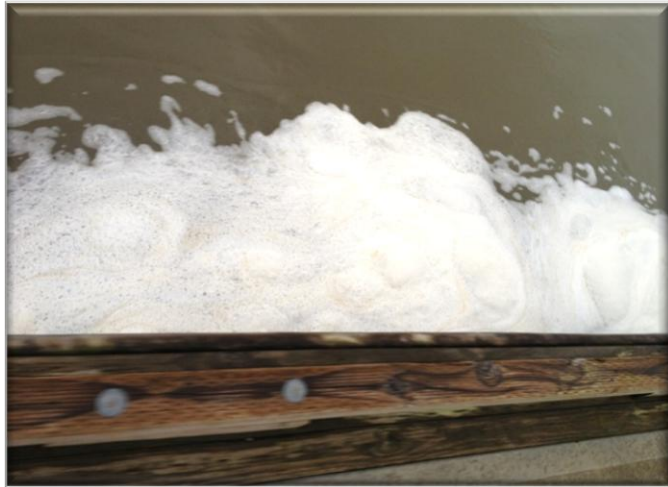
Figure 7 White foam with brown streaks running through it.
