SUMMARY REPORT
FOR THE
NEW YORK CITY SCHOOL CONSTRUCTION AUTHORITY
PILOT STUDY TO
ADDRESS PCB CAULK IN NEW YORK CITY SCHOOL BUILDINGS

USEPA CONSENT AGREEMENT AND FINAL ORDER
DOCKET NUMBER: TSCA-02-2010-9201

TRC ENGINEERS, INC. PROJECT NO.: 195168.1000.0000

May 24, 2013

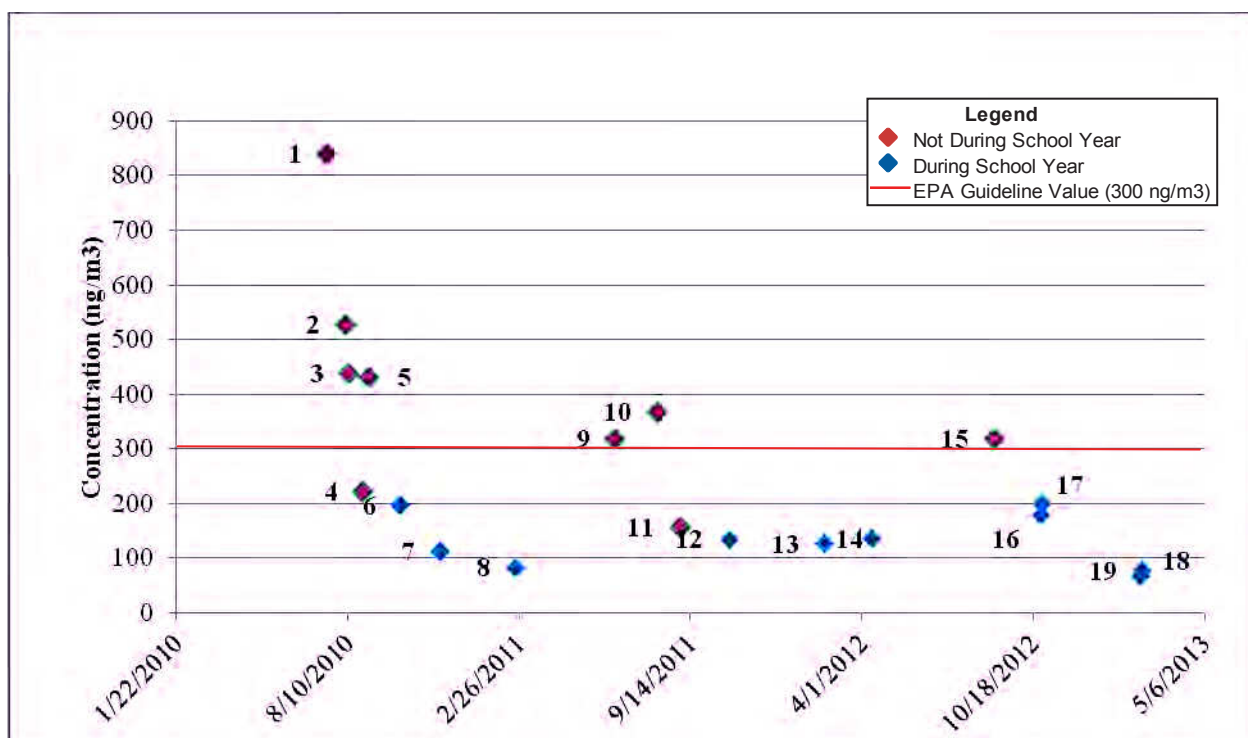
Figure 2.1 – P.S. 199M Building Average Concentration Over Time

Key to Air Sampling Events:

- 1 – June 17, 2010 pre-remedial sampling
- 2 – August 7, 2010 post-remedial sampling
- 3 – August 11, 2010 post-remedial resampling
- 4 – August 27, 2010 post-light fixture replacement sampling
- 5 – September 3, 2010 post-encapsulation sampling
- 6 – October 11, 2010 post-ventilation sampling
- 7 – November 26, 2010 winter conditions sampling
- 8 – February 22, 2011 winter conditions sampling
- 9 – June 18, 2011 pre-remedial sampling
- 10 – August 6, 2011 post-remedial sampling
- 11 – September 2, 2011 post-carbon filtration sampling

- 12 – October 30, 2011 post-carbon filtration sampling
- 13 – February 17, 2012 winter conditions sampling
- 14 – April 12, 2012 spring conditions sampling
- 15 – September 2, 2012 summer conditions sampling
- 16 – October 26 and 27, 2012 fall conditions sampling
- 17 – October 28, 2012 fall conditions sampling
- 18 – February 21, 2013 winter conditions sampling
- 19 – February 22, 2013 winter conditions sampling

Between August 23, 2008, and February 22, 2013, twenty-five (25) rounds of wide-scale testing were performed in P.S. 199M. Four (4) of these rounds were performed prior to the initiation of the Pilot Study, and the other twenty-one (21) rounds were performed as part of the Pilot Study. Eight (8) rounds of sampling were performed in the month of August, five (5) rounds in October, four rounds in February, two (2) rounds in September, and one (1) round each in January, April, June, July and November. Building-wide monthly PCB averages ranged from a high of 839.67 ng/m³, measured in July 2010, to a low of 67.24 ng/m³, in February 2013. Refer to Figure 2.1 below for a graphical representation of the building-wide airborne PCB average concentration trend since the beginning of the Pilot Study in June 2010. The same trend has also been noted in P.S. 309K, as detailed in Supplemental Report #1 located in Appendix M of the RIR.

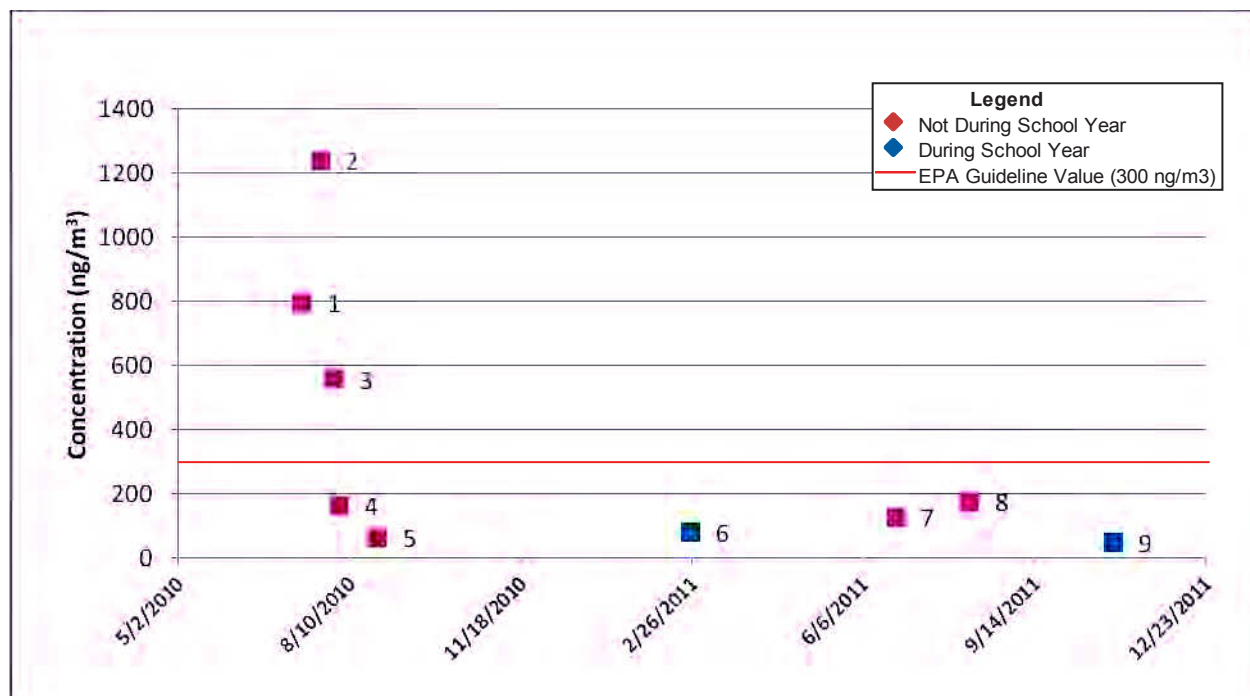
Figure 2.2- P.S. 309K Building Average Airborne PCB Concentration Over Time

Key to Air Sampling Events:

- 1 – July 13, 2010 pre-remedial sampling
- 2 – July 24, 2010 pre-remedial sampling
- 3 – August 1, 2010 post-remedial resampling
- 4 – August 4, 2010 post-ventilation
- 5 – August 26, 2010 post-light fixture replacement sampling
- 6 – February 25, 2011 winter conditions sampling
- 7 – June 25, 2011 pre-remedial sampling
- 8 – August 7, 2011 post-remedial sampling
- 9 – October 30, 2011 fall conditions sampling

Nine rounds of wide-scale testing were performed in P.S. 309K from July 2010 to October 30, 2011. Six rounds of sampling were performed in August, two rounds in July, and one round each in February, June and October. Building-wide monthly PCB averages ranged from a high of 1,240 ng/m³, measured in July 2010, to a low of 49.8 ng/m³, measured in October 2011. See Figure 2.2 for a graphical representation of the building-wide airborne PCB average concentration trend since the beginning of the Pilot Study in July 2010.
